**TRANSPORTATION SCIENCES
CRASH DATA RESEARCH CENTER**

Veridian Engineering
Calspan Operations
Buffalo, New York 14225

**CALSPAN ON-SITE AIR BAG RELATED CHILD FATALITY INVESTIGATION
CALSPAN CASE NO. CA96-010
VEHICLE - 1996 DODGE CARAVAN SE
LOCATION - TENNESSEE
CRASH DATE - 1996**

Contract No. DTNH22-94-07058

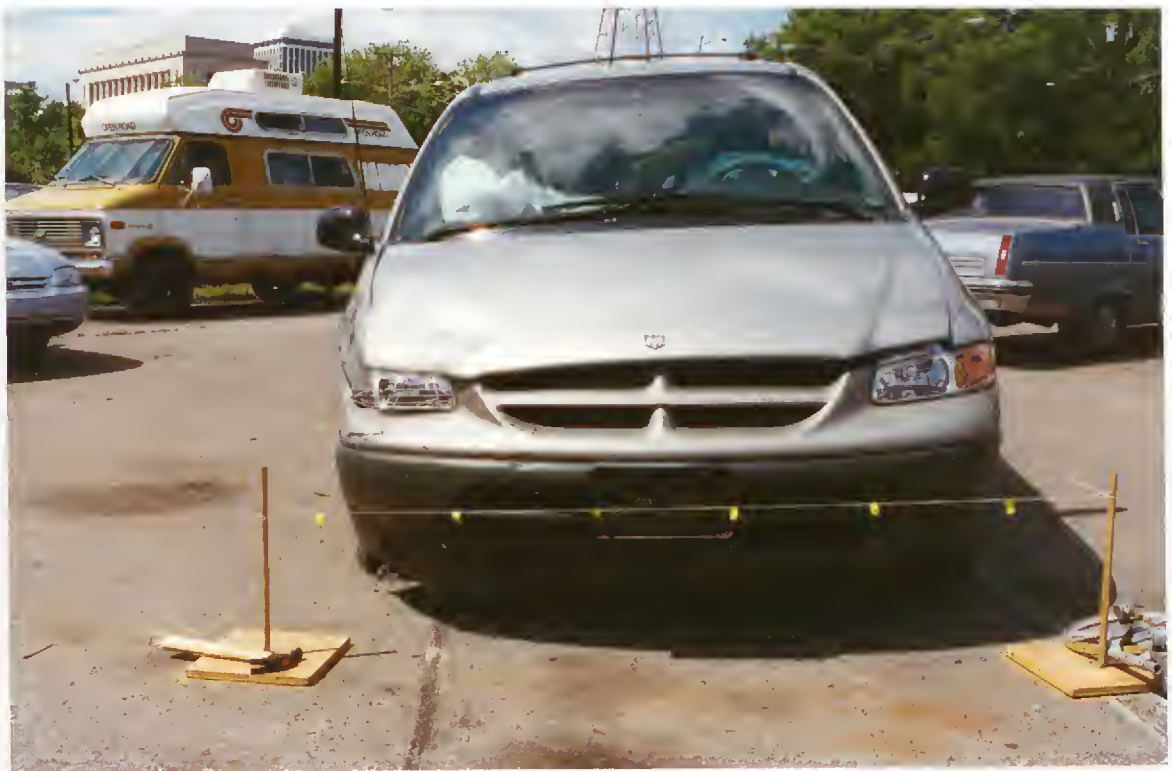
The 1996 Dodge Grand Caravan SE sustained moderate damage to the front right area of the vehicle as a result of its impact sequence with the left front side area of the 1988 Mercury Cougar. The direct contact damage began 12.7 cm (5.0 in) right of center and extended 66.0 cm (26.0 in) to the front right corner. Maximum residual crush was 3.3 cm (1.25") located at the right corner of the bumper reinforcement bar. The documented crush profile over the full width of the reinforcement bar was as follows: C1=0, C2=0, C3=0, C4=0.6 cm (0.25 in), C5=1.0 cm (0.38 in), C6=3.3 cm (1.25 in). Damaged components included the front bumper fascia, bumper reinforcement bar, hood, right headlamp assembly, and the right front fender.

28. Frontal damage to the Dodge Caravan.

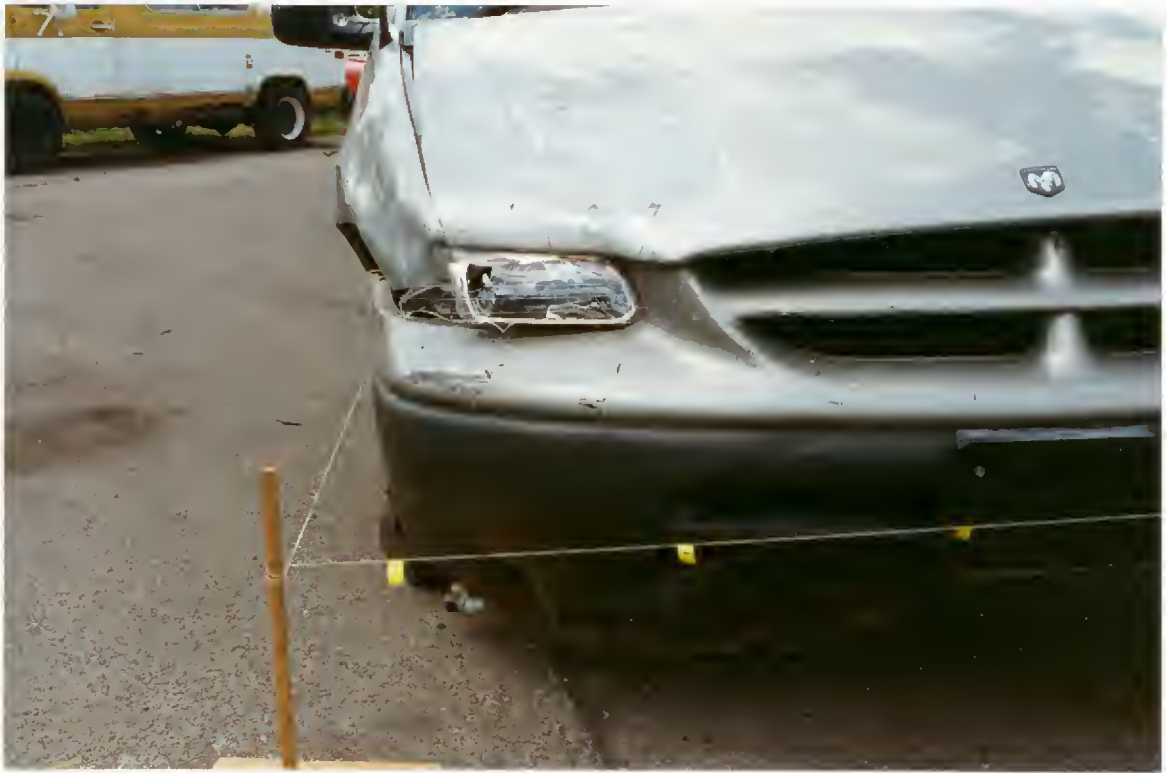
30. View of the direct contact damage to the Dodge Caravan.

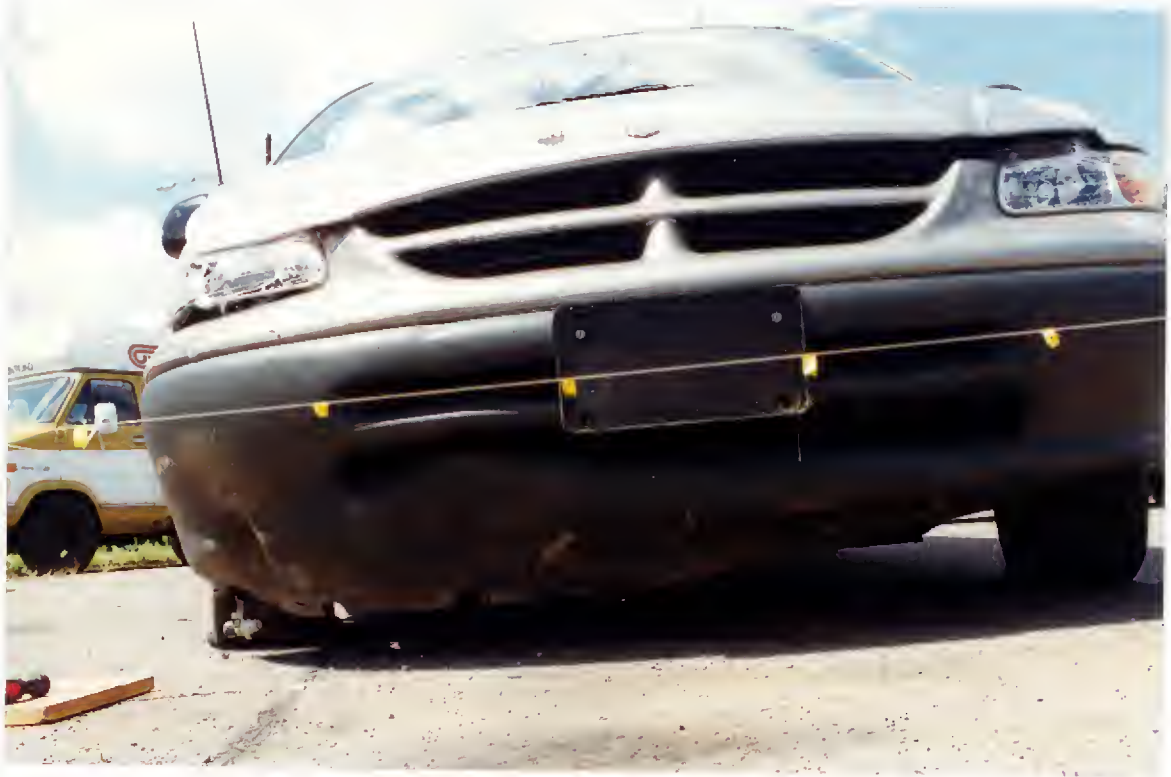
As the Caravan came to rest, the front right undercarriage area impacted a drainage ditch which abraded the underside of the bumper fascia. The contact damage began at the right corner of the fascia and extended 115.6 cm (45.5 in) to the left. The air dam aspect of the fascia was displaced upward approximately 3.8 cm (1.5 in).

34. Front view of the damage to the lower surface of the bumper fascia.

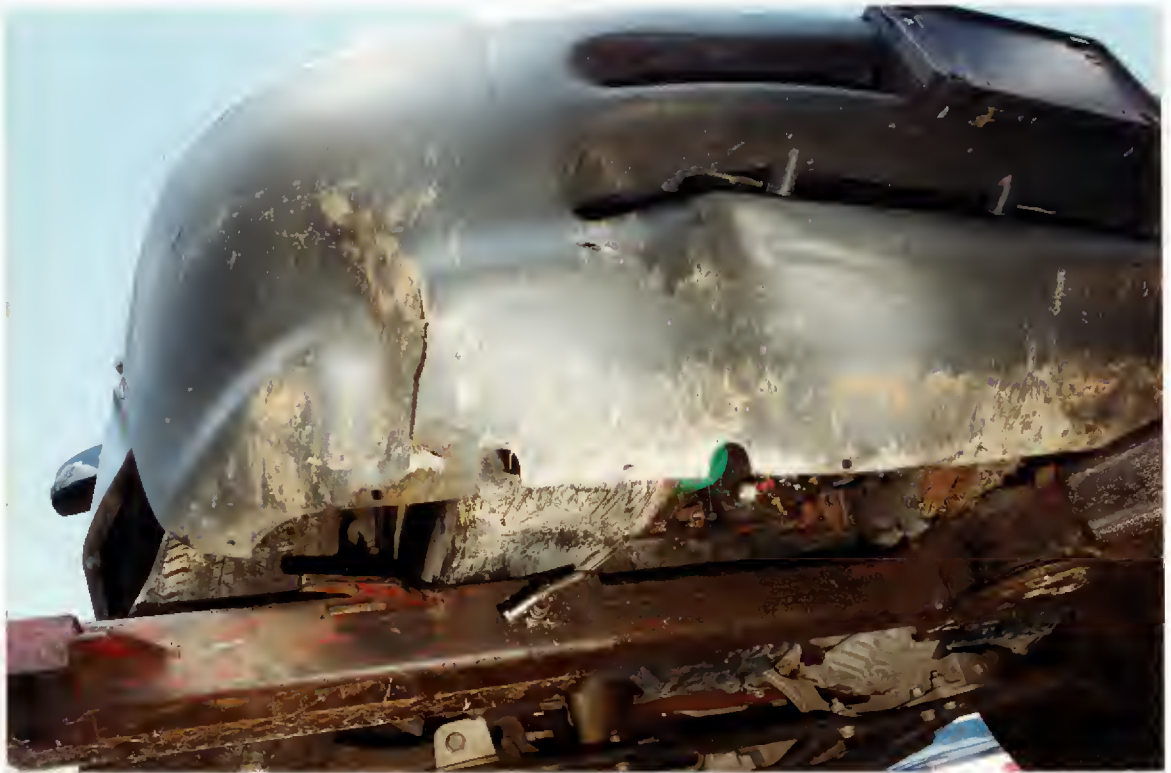
36. Close up view of damage to the lower surface of the bumper fascia.

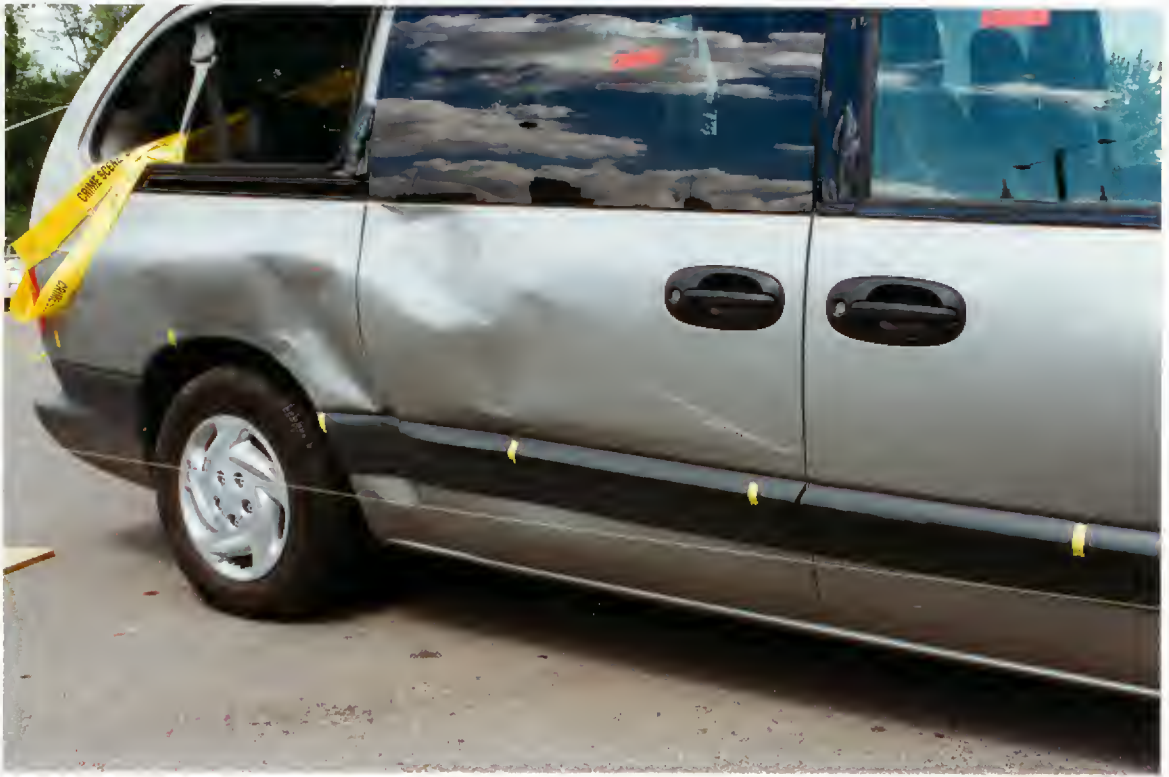
Secondary damage resulted from a subsequent sideslap impact with the Mercury Cougar. The direct contact damage began 66.8 cm (23.6 in) aft of the right rear axle and extended forward 265.4 cm (104.5 in). A maximum lateral deformation of 3.2 cm (1.25 in) was located 54.6 cm (21.5 in) forward of the right rear axle at the base of the C-pillar. The superficial crush profile was as follows: C1=0 cm, C2=1.9 cm (0.75 in), C3=0.6 cm (0.25 in), C4=1.3 cm (0.5 in), C5=0 cm, C6=0 cm.

44. Right rear side slap damage to the Dodge Caravan.

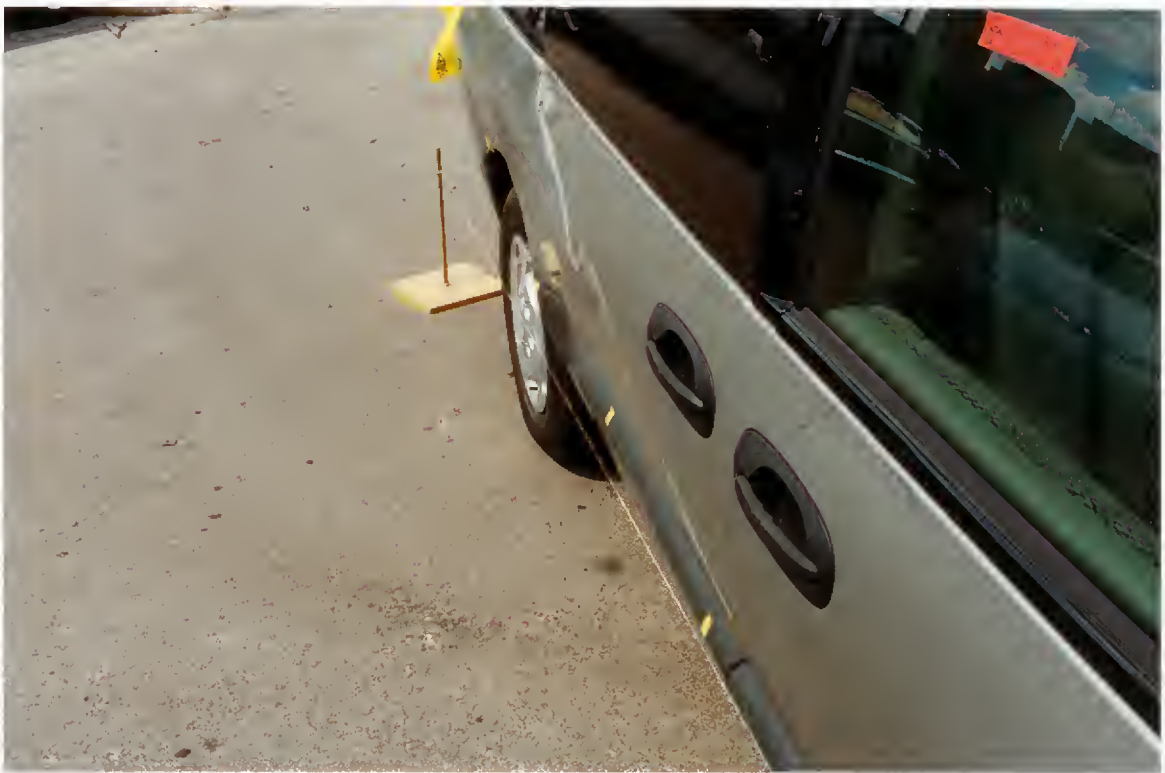
45. View of the right side direct contact damage.

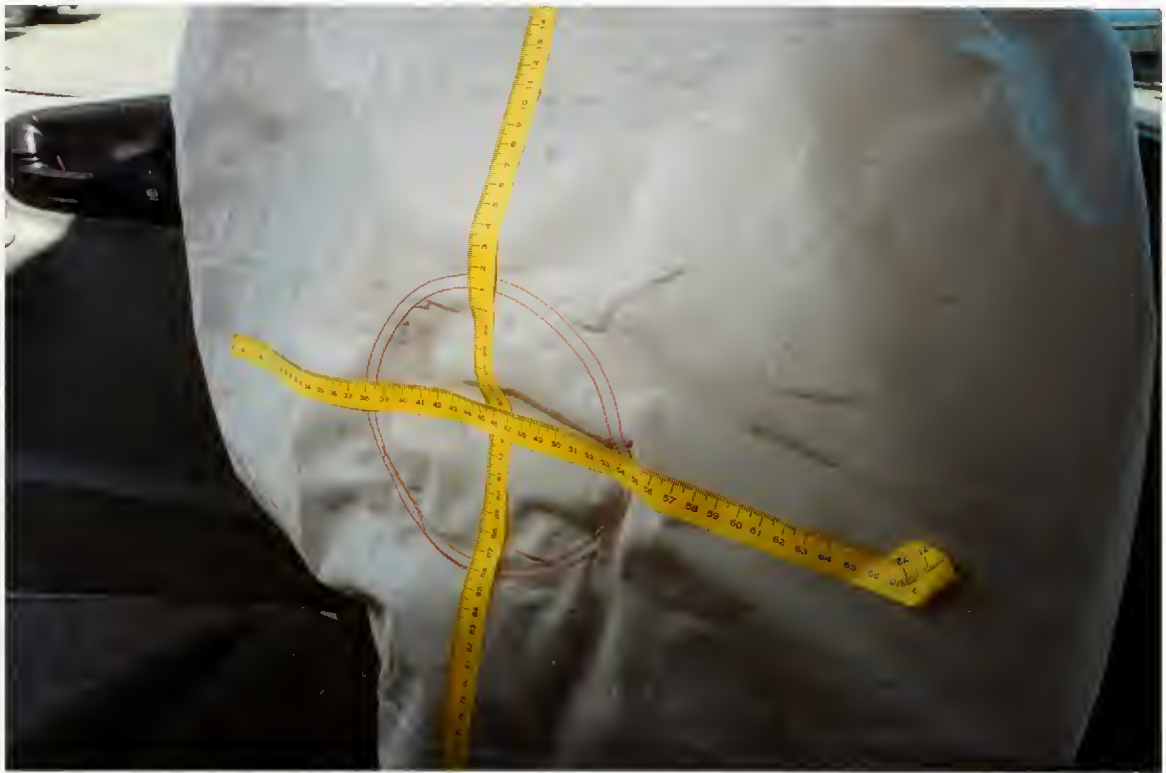
side air bag. There was no evidence of contact (lipstick, makeup transfers) to the driver's air bag. Several blood stains were noted to the lower left quadrant of the bag. The driver's air bag deployed from a typical steering wheel mounted module assembly. The bag was tethered by internal straps and was porous in design with no direct vent ports. There was no damage to the driver's air bag.

53. Close-up view of blood spatters on the lower left quadrant of the air bag.

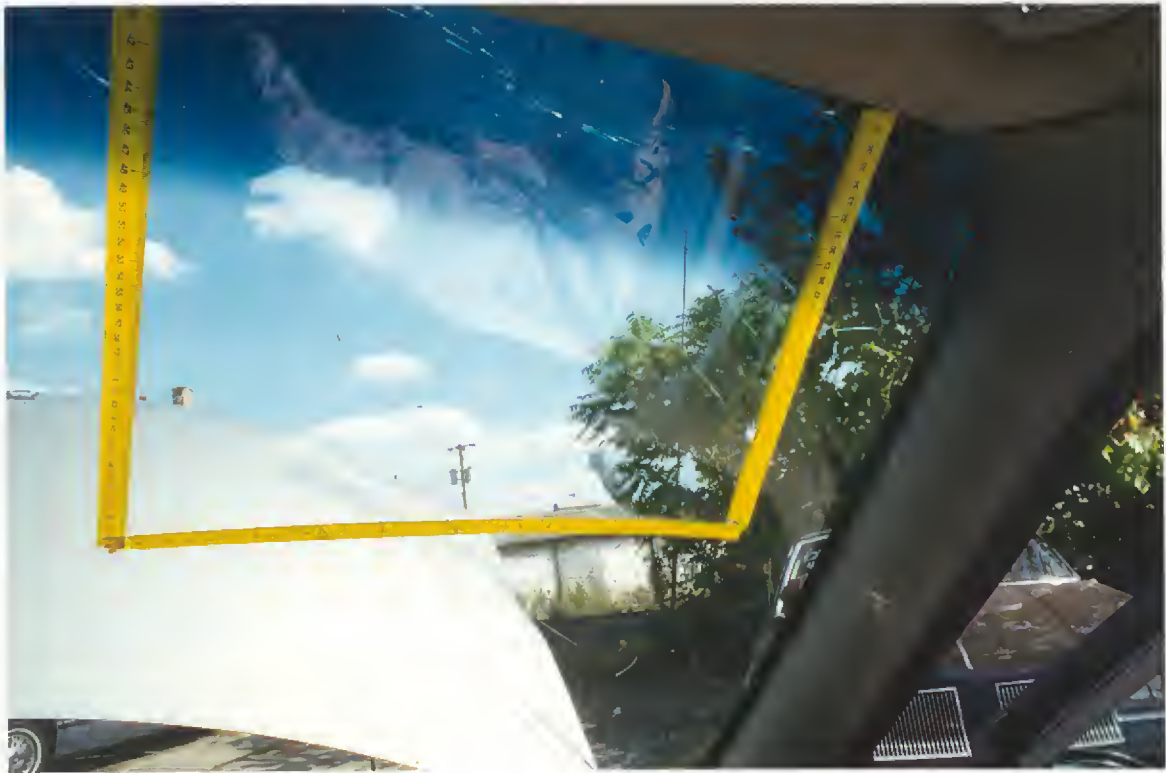
The forward position of the child occupant pre-crash, altered the normal deployment path of the air bag, deflecting the bag upward into the windshield and rearview mirror. Bag contact with the glazing was evidence by air bag fabric transfers on the glass and a fracture to the windshield. The rearview mirror was subsequently separated from its mount and displaced to the left.

65. Overall view of the windshield fracture caused by the deploying passenger side air bag.

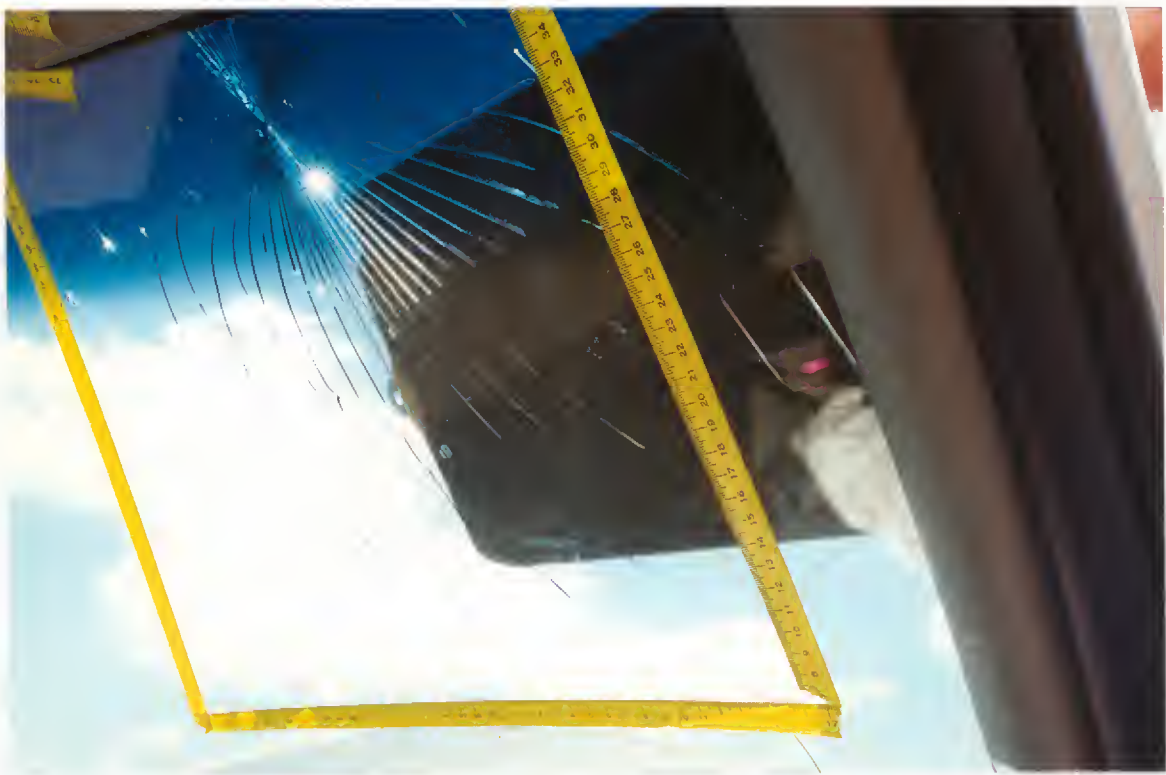
The deployment path of the passenger side air bag was altered by the forward position of the front right child passenger which resulted in bag contact to the windshield, headliner, and the rear view mirror. A large air bag fabric transfer was located to the windshield 35.6-54.6 cm (14.0-21.5 in) right of the vehicle's centerline and 2.5-31.8 cm (1.0-12.5 in) below the windshield header (refer to Photograph No. 66). A windshield spider web-type cracked was located 41.3 cm (16.25 in) right of center and 5.1 cm (2.0 in) below the headliner (refer to Photograph No. 65-67). Also, an air bag fabric abrasion was located on the headliner 27.9-33.0 cm (11.0-13.0 in) right of center which extended 1.3-5.1 cm (0.5-2.0 in) rearward (refer to Photograph No. 68).

66. Right view of the windshield fracture and air bag fabric transfers.

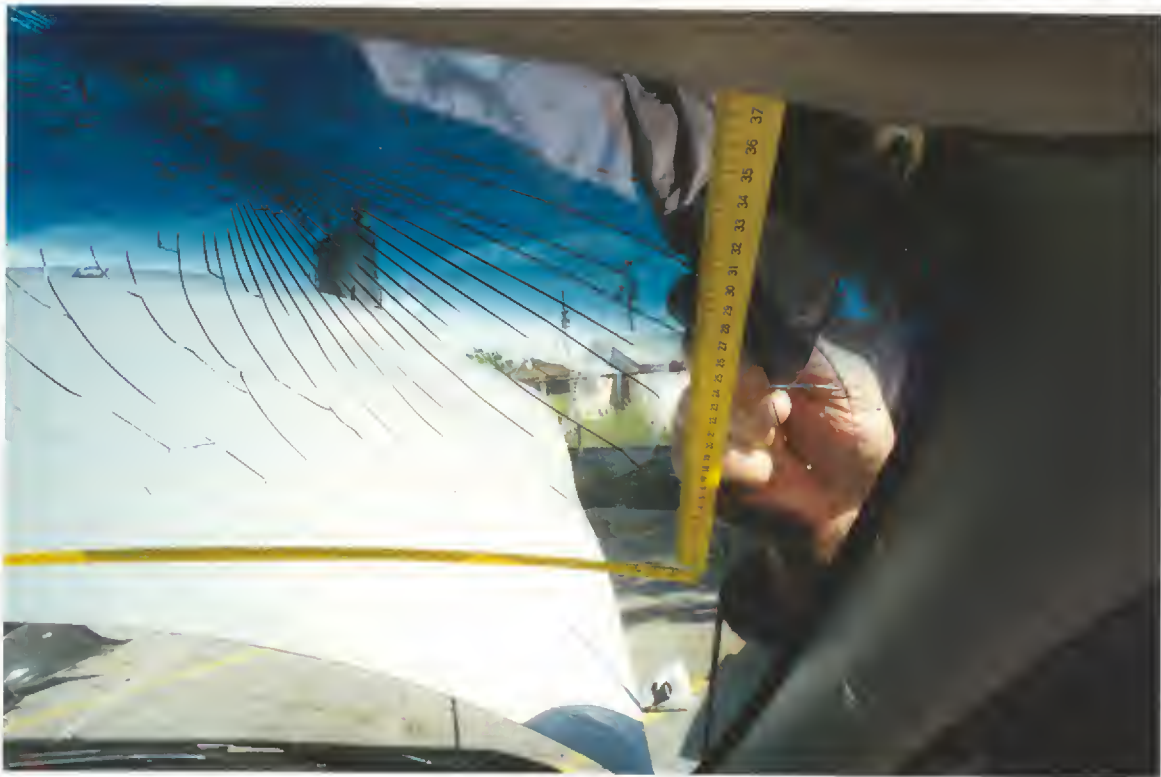
67. Close-up view of the windshield fracture and the air bag fabric transfers.

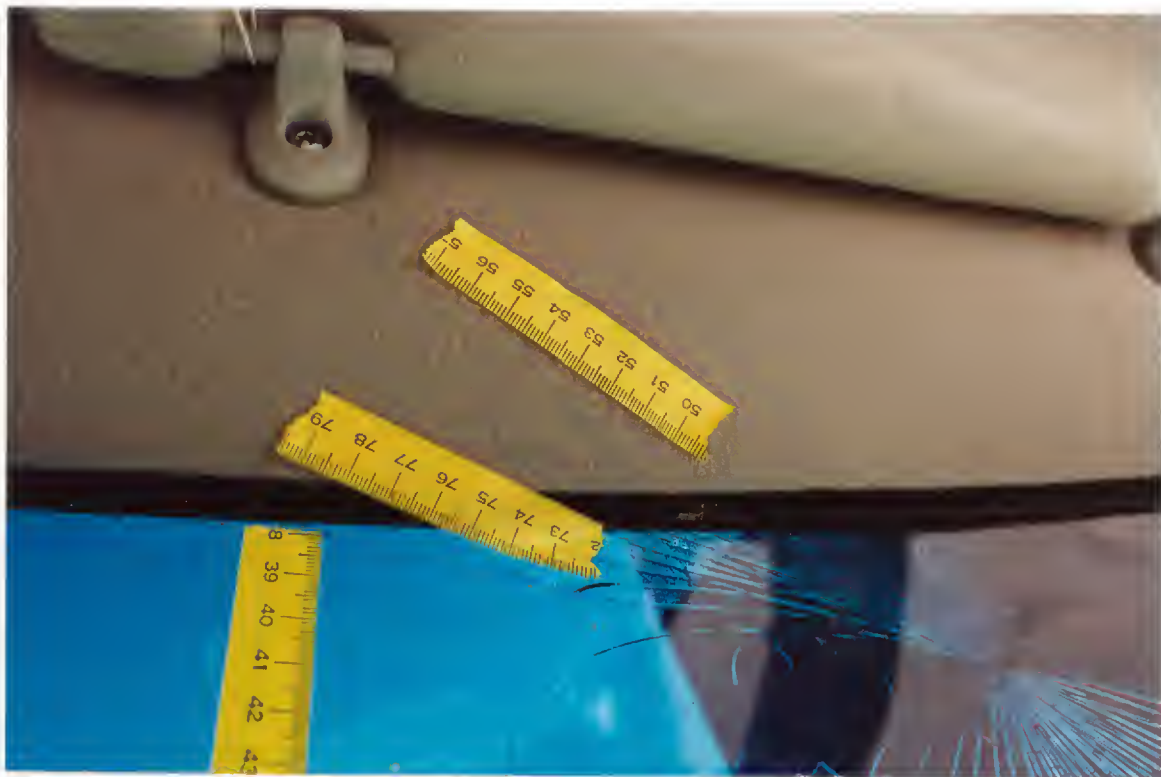
68. Close-up view of a fabric abrasion on the header/headliner.

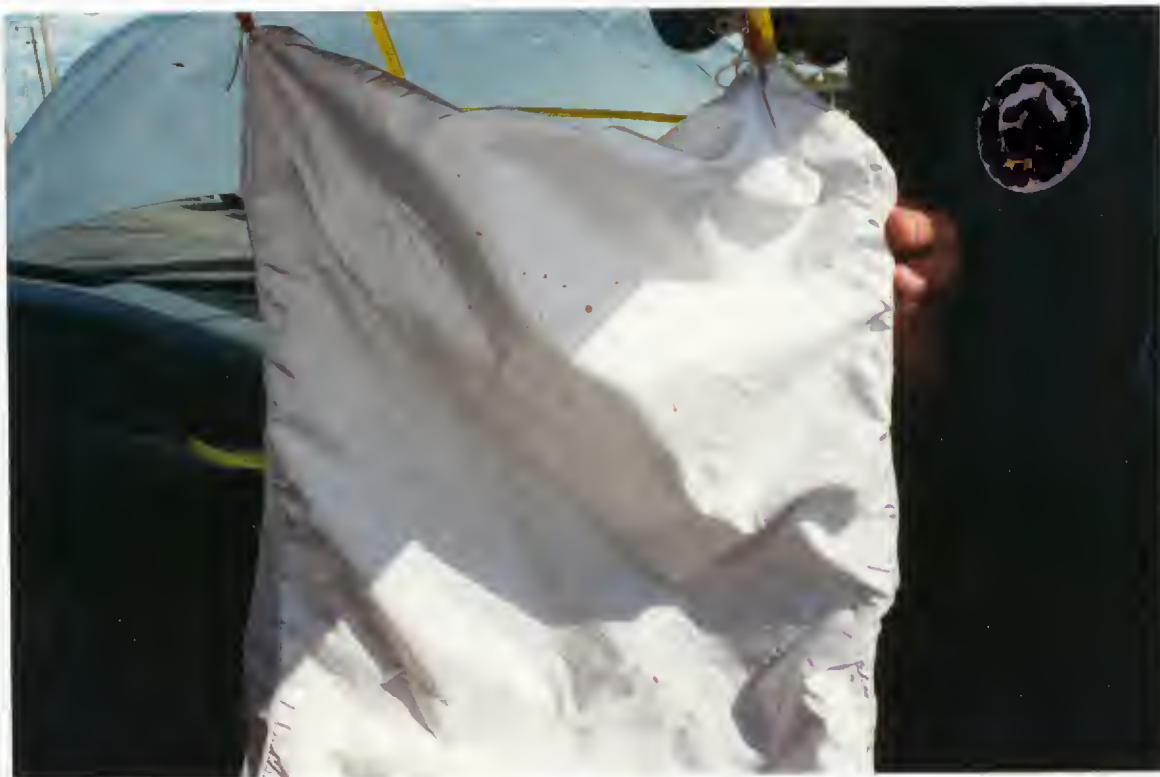
Three blood spatter patterns were noted to the front right air bag. The first spatter was located 17.8-38.1 cm (7.0-15.0 in) right of the left side of the air bag and 7.6-20.3 cm (3.0-

8.0 in) down from the top of the bag (refer to Photograph No. 70). The second blood spatter was noted 30.5-38.1 cm (12.0-15.0 in) below the top of the bag and 0.0-5.1 cm (0.0-2.0 in) inboard of the right side of the bag (refer to Photograph No. 73). A third blood spatter was located 54.6-58.4 cm (21.5-23.0 in) below the top of the bag and 14.0-21.6 cm (5.5-8.5 in) inboard of the right side (refer to Photograph No. 72). A probable body fluid/material (tissue or nasal expulsion) transfer of 12.7 cm (5.0 in) in length was located on the right side of the passenger side air bag, centered between the side seams and 7.6 cm (3.0 in) above the lower seam. Gray vinyl transfers were present at the bottom right sector of the bag 13.3-5.1 cm (5.15-2.0 in) up from the bottom seam and 7.0-17.8 cm (2.75-7.0 in) left of the right seam (refer to Photograph No. 74-75). These resulted from bag expansion within the module assembly.

70. View of blood spatters on the face of the air bag at the 12 o'clock position.

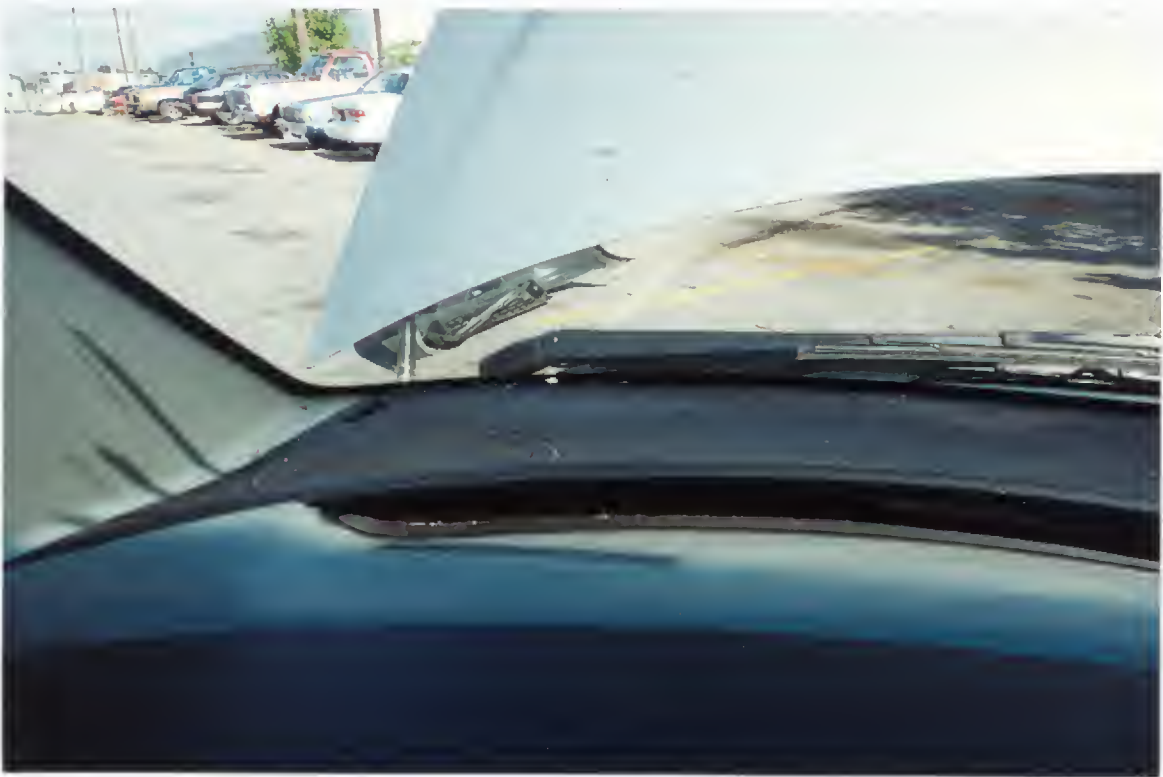
As the passenger air bag deployed from the mid instrument panel, the expanding air bag contacted the child occupant's face, resulting in abrasions across the forehead and onto left cheek. Her initial involvement with the deploying air bag resulted in a laceration of the upper lip and an avulsion of an upper front tooth. The tooth was found on the upper instrument panel forward of the steering assembly.

79. View of the avulsed tooth found on the left side of the instrument panel.

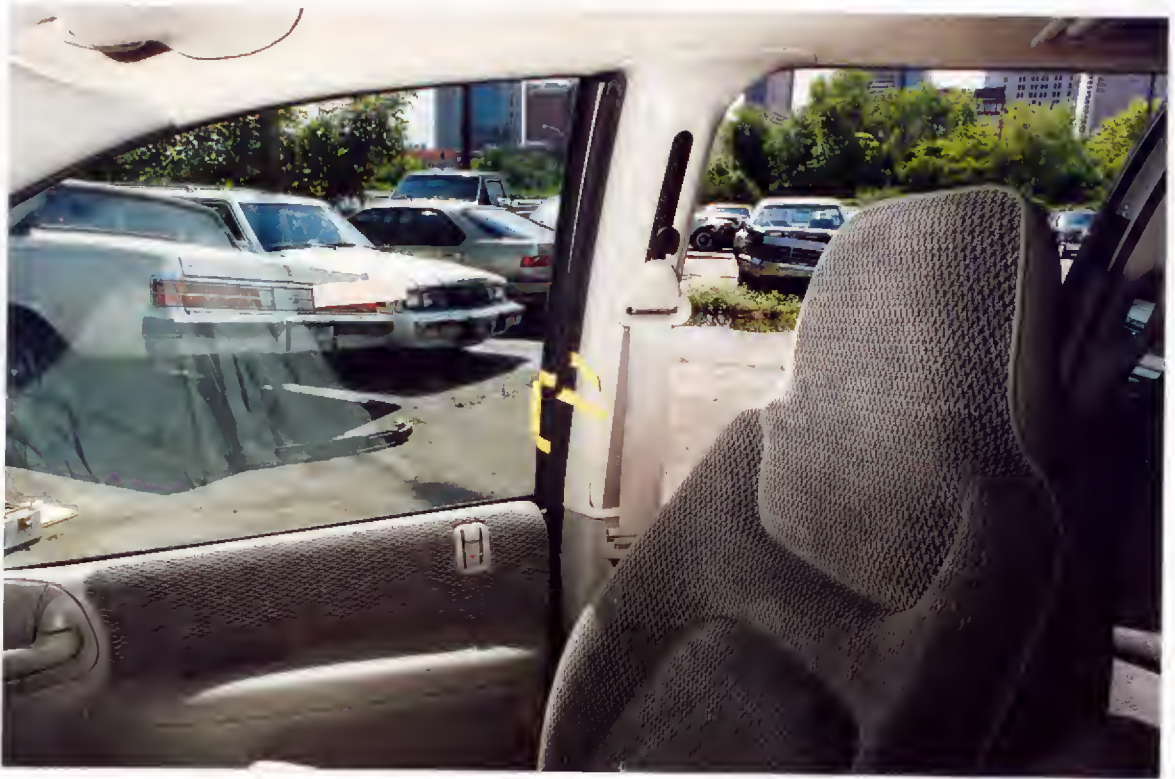
The posterior scalp of the front right child passenger impacted the right upper B-pillar and door window frame during her rebound trajectory. The rubber strip at the trailing edge of the right front door window was deformed by the head contact. The deformed area of the gasket involved 5.0 mm (0.2 in) of compression. The compression was located 11.1-13.7 cm (4.4-5.4 in) above the beltline and 47.0 cm (18.5 in) above the seat cushion (refer to Photograph No. 93-95). A dark oily smudge was noted on the B-pillar 17.1-18.4 cm (6.75-7.25 in) above

93. View of a rebound contact at the right B-pillar/window juncture.

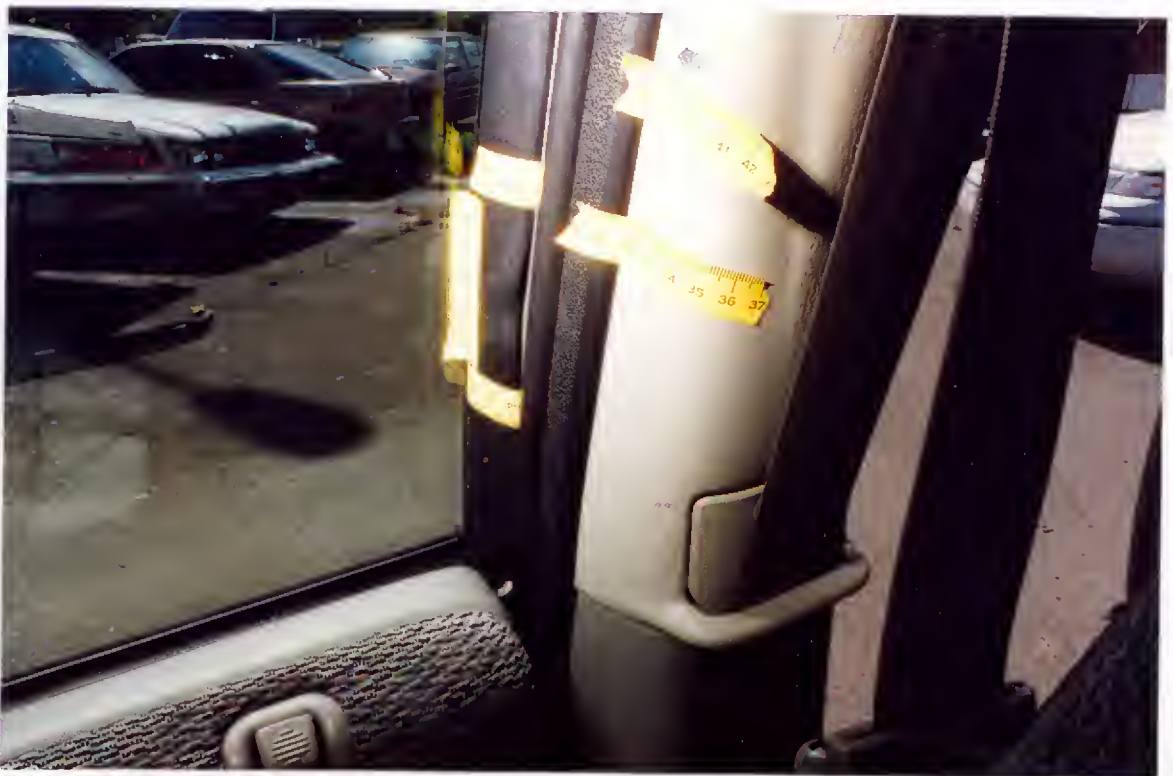
94. Close-up view of the rebound contact.

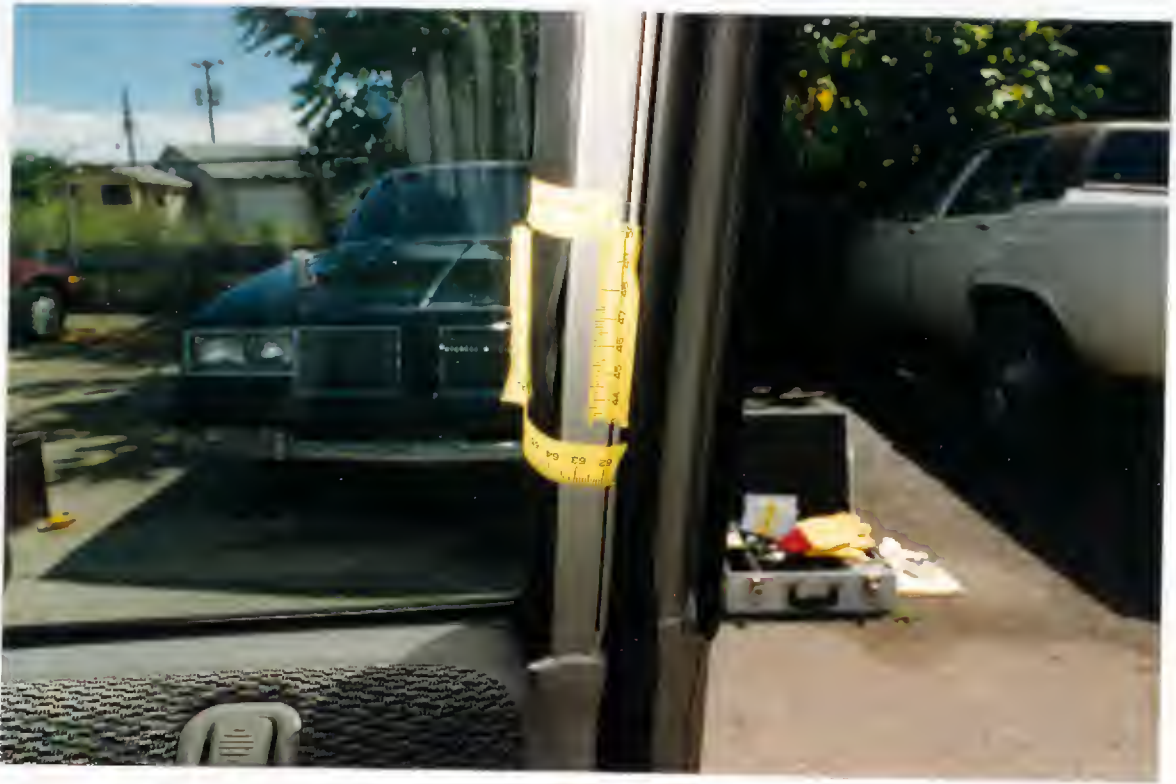
95. Close-up view of the rebound contact.

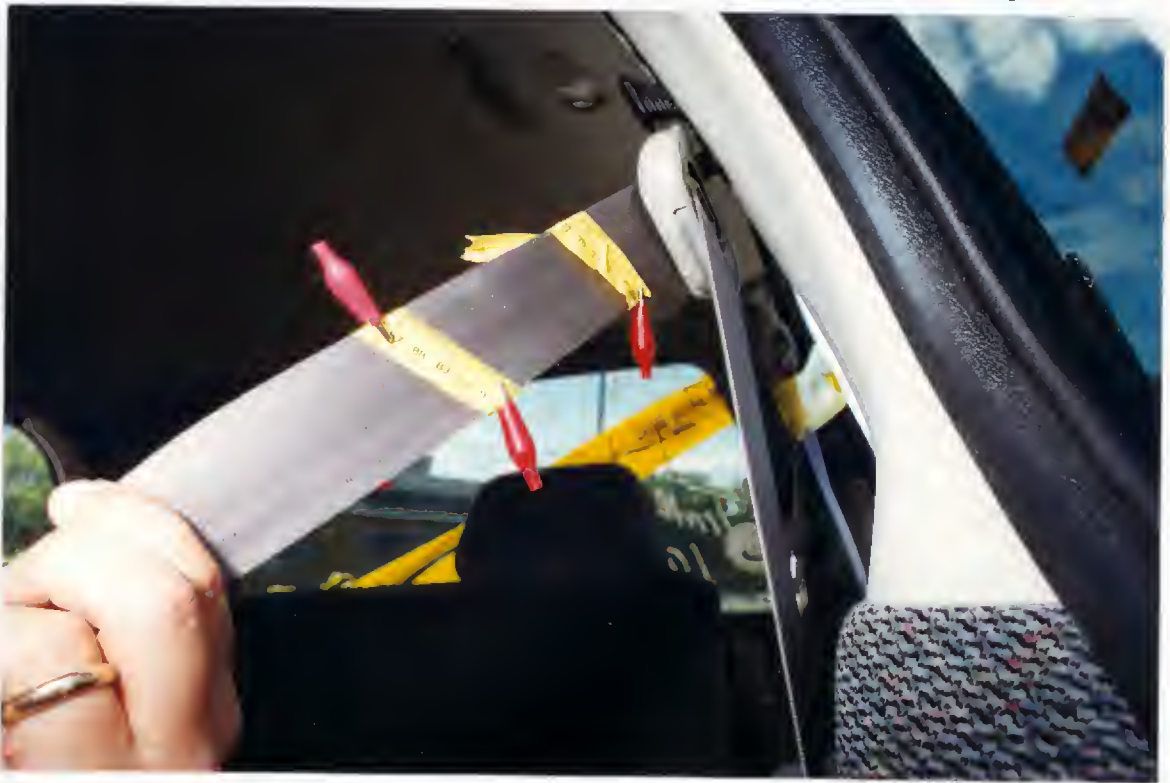
child safety seat on the seat cushion. Abrasions were noted to the shoulder belt webbing and to the plastic extrusion at the seat cushion/seat back juncture. In addition, the loading produced a D-ring transfer to the shoulder belt webbing. This evidence is documented in Photograph Nos. 97-102.

101. Close-up of an abrasion on the upper portion of restraint webbing near the D-ring.

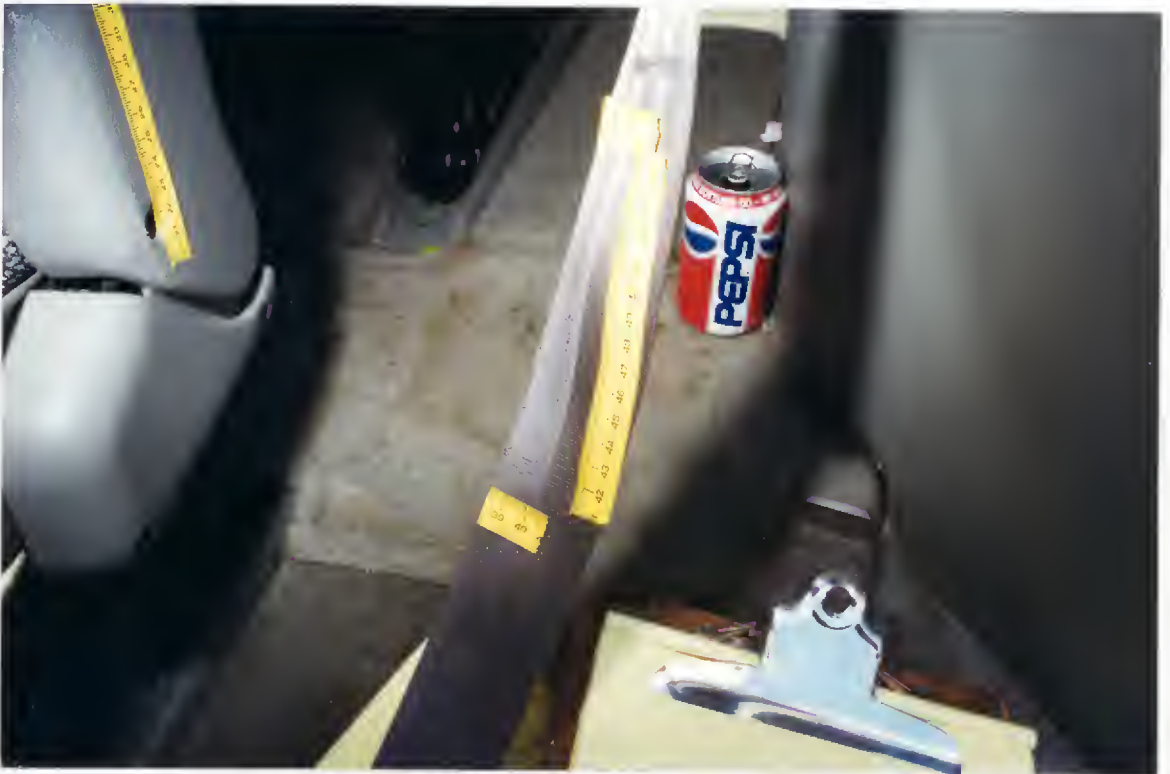
102. Close-up of an abrasion on the restraint webbing caused by the plastic cover.

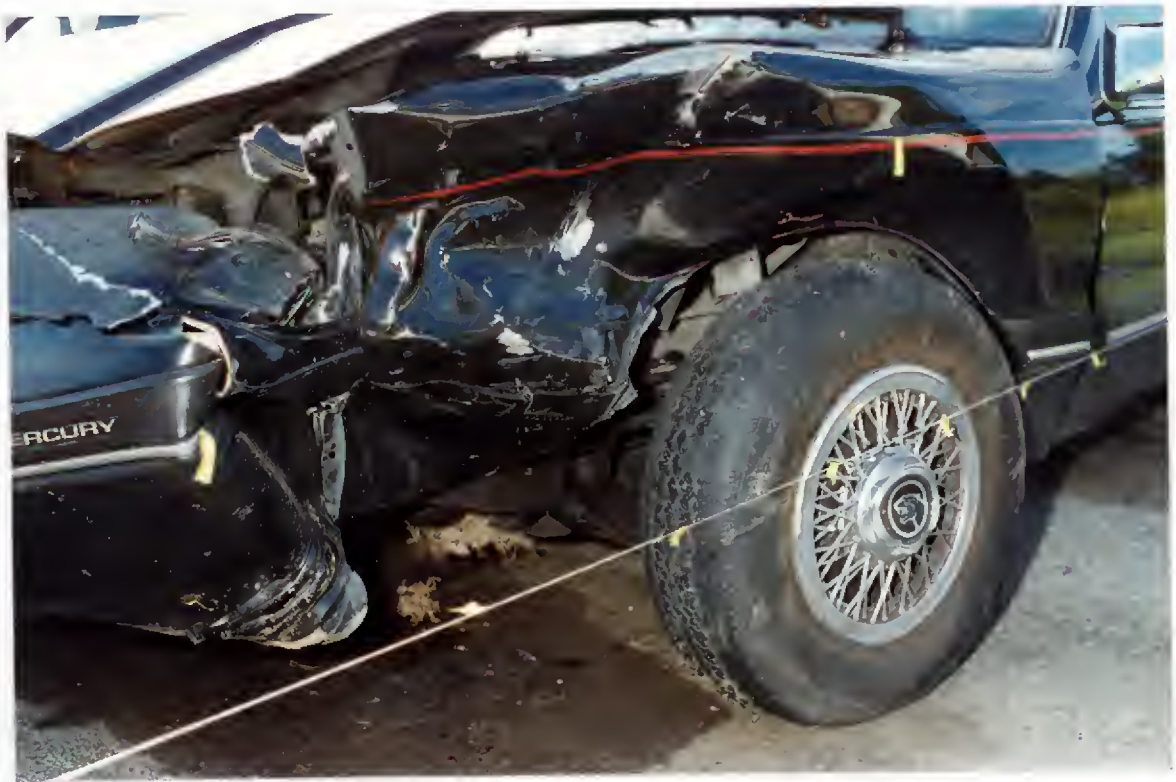
The 1988 Mercury Cougar sustained moderate left side damage from its impact sequence with the Dodge Caravan. The direct contact damage began 8.9 cm (3.5 in) rearward of the left front axle and extended 99.1 cm (39.0 in) forward to the front bumper corner. The combined induced and direct contact damage began at the trailing edge of the left front fender and extended 141.5 cm (55.75 in) forward to the bumper corner. Maximum crush was 50.1 cm (20.0 in) located at the leading edge of the left front fender, 61.0 cm (24.0 in) forward of the left front axle. The crush profile was as follows: C1=0, C2=13.0 cm (5.1 in), C3=22.9 cm (9.0 in), C4=34.3 cm (13.5 in), C5=35.8 cm (14.1 in), C6=27.4 cm (10.8 in).

107. Close-up view of the direct contact damage.

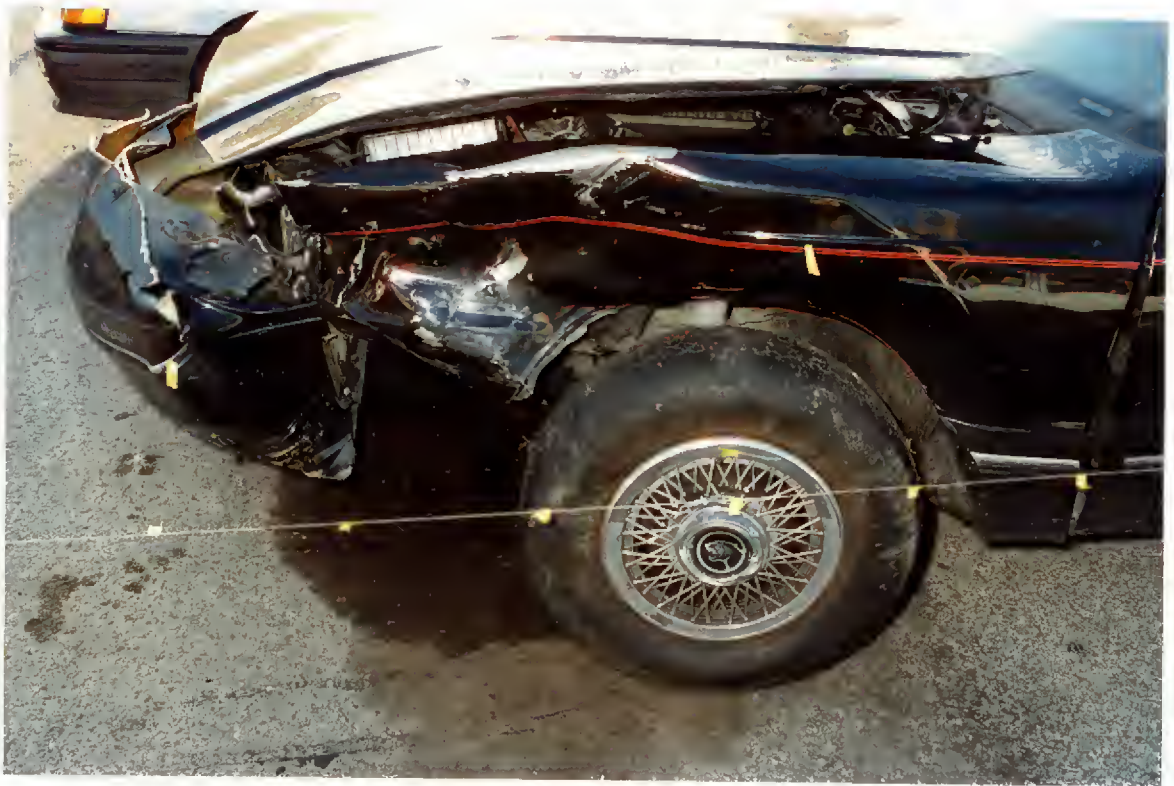
108. Left side view of the direct contact damage.

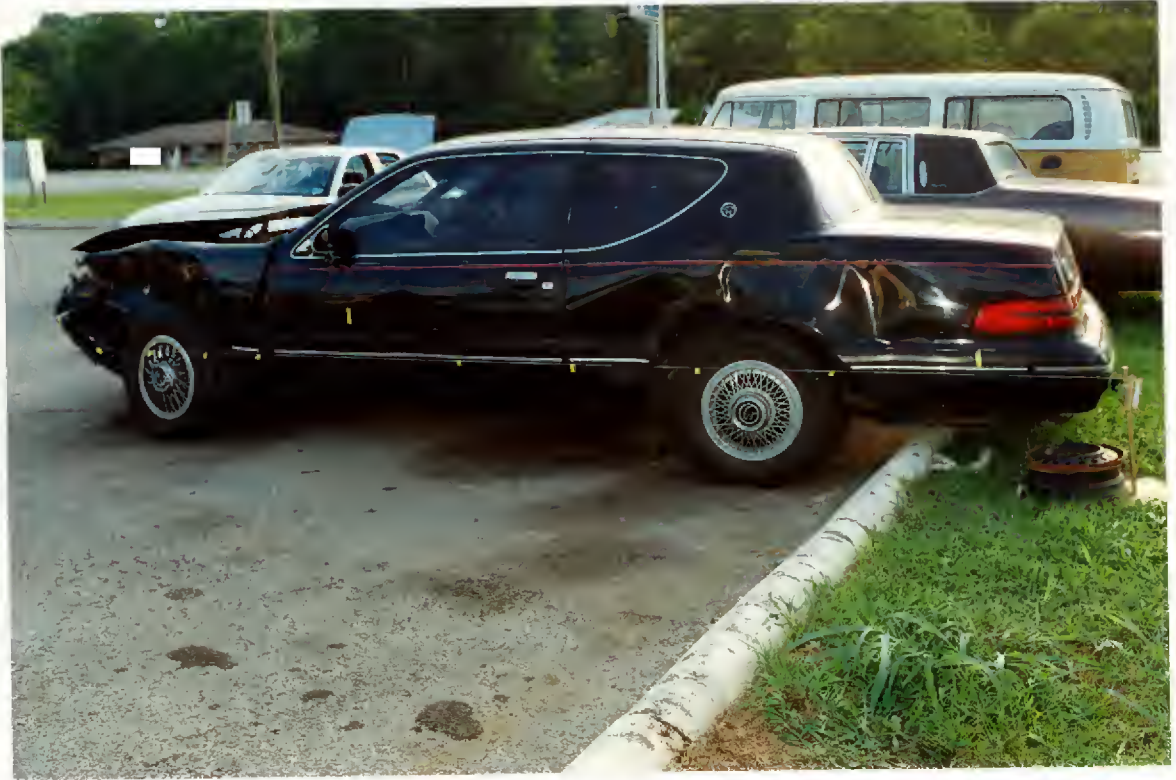
The secondary sideslap damage was minor with a maximum crush of 4.8 cm (1.9 in) located 17.1 cm (6.75 in) forward of the left rear axle. The direct contact damage began 81.3 cm (32.0 in) rearward of the left rear axle and extended 245.1 cm (96.5 in) forward. The crush profile for the sideslap was as follows: C1=0 cm, C2=3.3 cm (1.3 in), C3=4.8 cm (1.9 in), C4=0.6 cm (0.3 in), C5=0.3 cm (0.1 in), C6=0 cm. The left side rear view mirror, located 91.4 cm (36.0 in) rearward of the left front axle, was fractured by the secondary impact.

112. Left side view of the secondary (side slap) damage.
